EPRI Condenser Technology Seminar and Conference  
August 3 and 4th, 2011  
Wyndham Chicago, Chicago, Illinois

NRG Energy's Dunkirk station is located on Lake Erie, 55 miles southwest of Buffalo, in Dunkirk, New York. The 600-megawatt plant consists of four coal-fired units, including two 100-megawatt units that have been running since 1950, and two 200-megawatt units that went into service in 1959 and 1960.

Extending the Life of the Unit #4 Condenser at NRG - Dunkirk

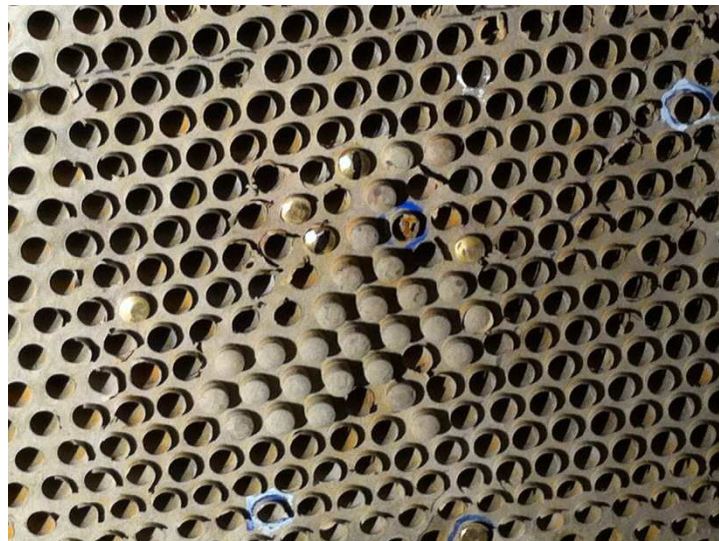
*Note the blue circle in the middle of the plugged tubes has a corroded scraper within it. This scraper was removed, but the obstruction within the tube could not be cleared.*

After arrival at site and equipment setup a cursory drying of the condenser and tubes is performed with oil and water free compressed air at 125 psi. During this initial dry activity it was discovered that over 600 tubes were completely obstructed by shells, mud, wood, and condenser tube cleaning scrapers that were left from previous cleanings. It was noted by the plant that they were aware of the plugged tubes and had tried to clear them 2 years ago, but were unsuccessful at doing so. By extensive manual rodding 200 tubes were cleared and returned to service. The remaining 400 plus were permanently plugged with brass tapered plugs.

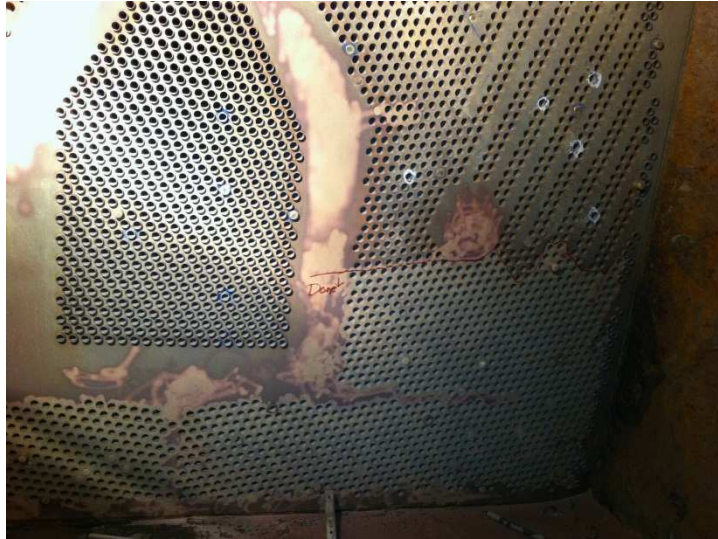
*Grit blasting in progress.*

Grit blasting was then performed on all tubes in order to remove any remaining deposits that could interfere with the adherence of the epoxy coating.

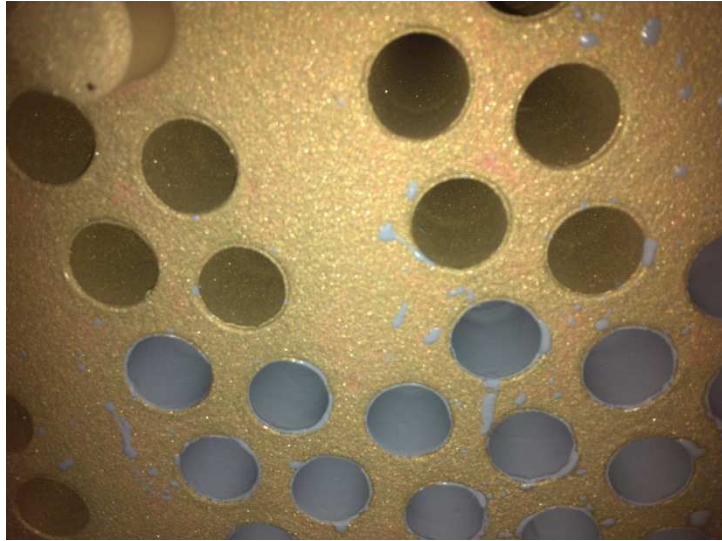
Tube coating in progress.

Coating was then performed utilizing Curran Internationals patented condenser tube spraying machines. Each machine can spray three tubes at a time at six feet per second. Coating hoses were propelled outside of the outlet end of the tube and then pulled through the complete tube terminating the spray after fifteen feet. Each tube received a 2-3 mil layer of Curran Condenser Tube Coating.

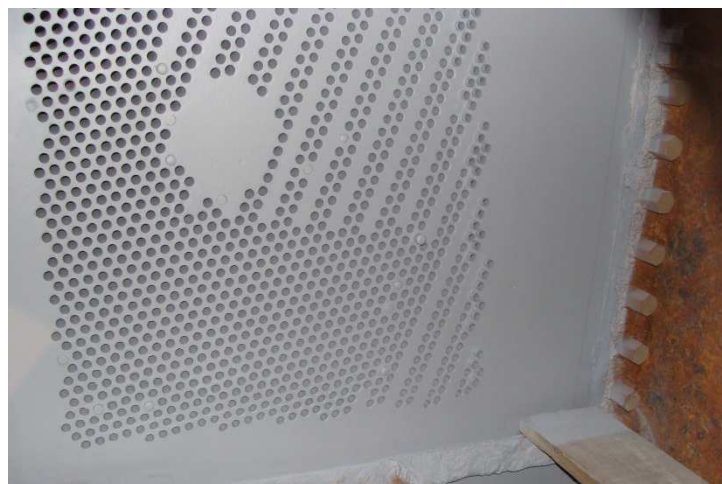
*Above are pictures of the outlet tubesheet with a single coat of Phenolic Epoxy applied to tie in the tube coating with the tubesheet.*

A single coat of the Phenolic Epoxy was spray applied to the outlet tubesheet to achieve a 4-6 mil DFT.
