## **Condenser Tube-sheet Coating to repair a problem with Galvanic Attack**

2 pass, single shell unit with 22,332 tubes 24.4mm OD X .7mm wall and 13,090mm long  
A249 TP304 Stainless steel tubes  
Tube-sheet are SS400 Steel 40 mm thick

AES Alicura S.A. Parana Power Plant

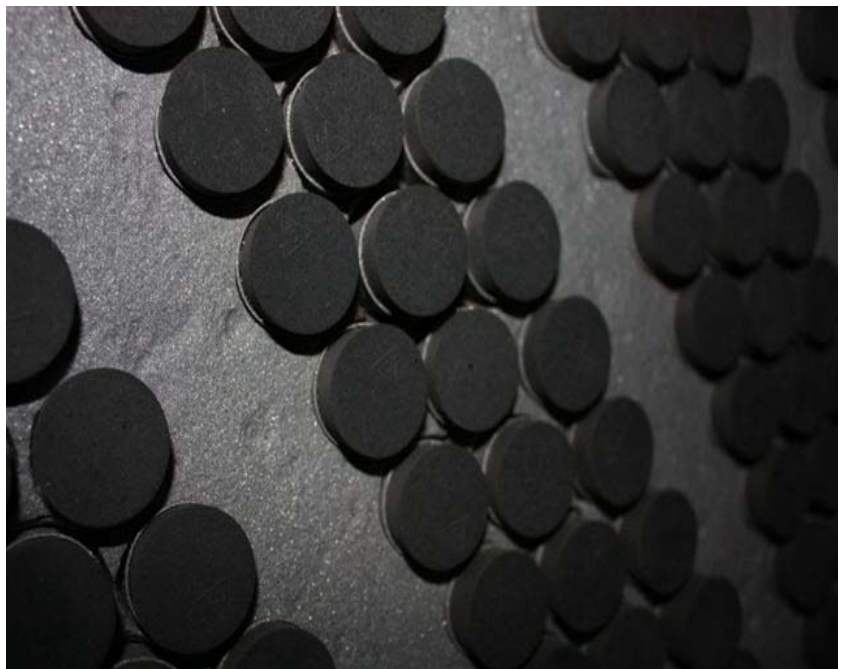
Tube-sheet after grit blasting. Note how even the small tube to tube-sheet crevasse is blasted clean.

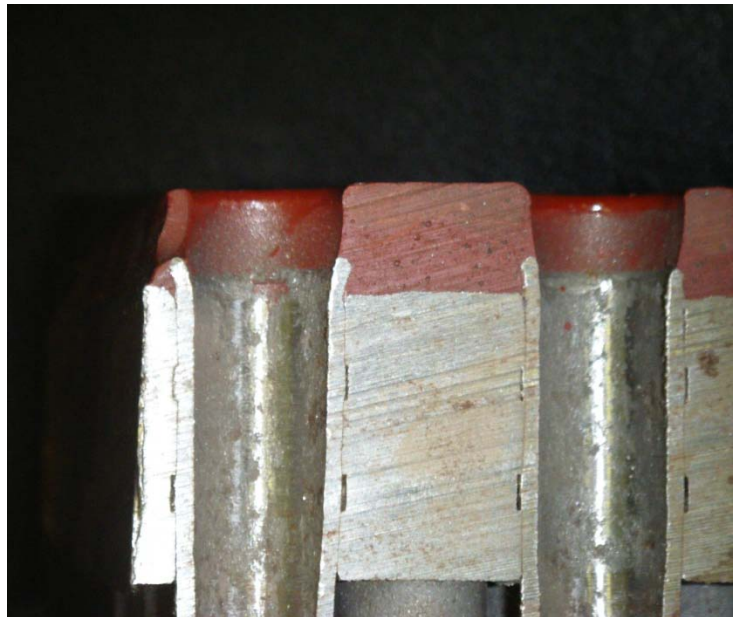
This picture is a cross-section example of Curran's thick film Tube-sheet coating. This is the same coating (different color) as in the case above.

Note how the coating (the thin film liquid grade coating) wets into the tube to tube-sheet crack. Then the thick film coating is applied on top of the liquid grade.
