May, 2018

Specifying the **Right Protective Coating** for Worst-Case Conditions

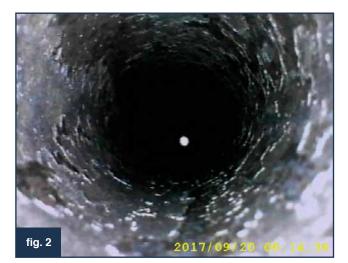
A borescope image shows comparable tubes hydro-lanced and grit blasted in 40-seconds! An inspection probe passed through the entire tube, satisfying inspectors with data acquired. (fig. 3)

Straight and U-tube carbon steel exchangers were made available. Hydro-lancing had been completed, but remaining surface-scale restricted the inspection probe from passing down tube more than a few inches from end. (fig. 2)

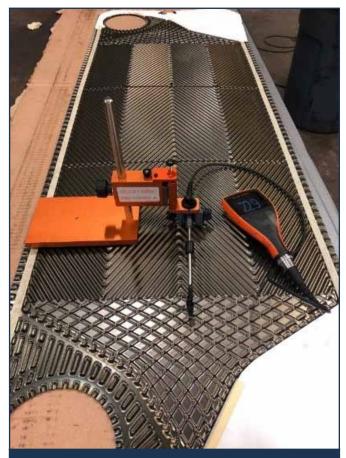
Exchanger plate with Curramix release coating applied to 23 microns total thickness.

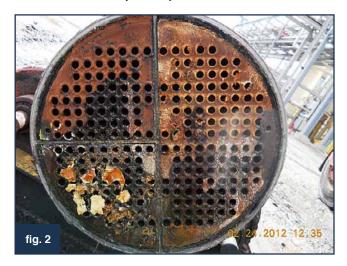
The **uncoated exchanger (fig. 2)** was pulled for hydroblast tube cleaning of cooling water foulant and scale. RFT inspection was performed on the tube IDs. The inspection found tubes with >70% indications after just four-years of service.
