### **Mid-South Refinery – 2006 Plant Wide Maintenance Turnaround Dry Abrasive Cleaning of Tube IDs**

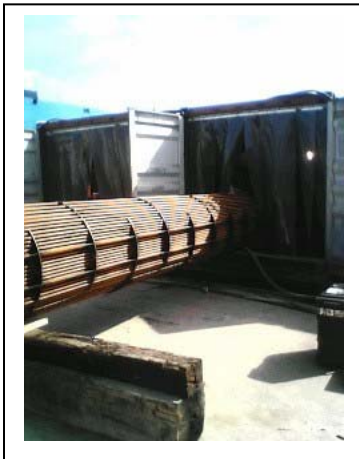
tagged for NDT inspection during the 2006 plant wide turnaround. The scope was to dry abrasive blast clean 100% of the tube IDs in each bundle for full inspection. The plant required about 10% of the exchangers in the scope to be cleaned in the unit; Curran International supplied containment tents for in-situ blast cleaning, and a blast shed (left) for work performed on the blast pad. Spent grit was contained and disposed in owner provided drums; a 300 CFM vacuum system contained dust. Other maintenance contractors were able to continue work uninterrupted while in-situ bundles were cleaned. Most bundles tagged for inspection were 16-20 foot straight length “U” tube bundles, carbon steel was the

predominate material, brass tubes were in the mix of bundles. With each bundle sample tubes were blasted a specified dwell time, visually inspected, and re-blasted as necessary to achieve the level of cleanliness required for the tube inspection. Dwell times specific to each bundle are used to blast clean the remaining tubes; depending on the bundle and operating conditions, dwell times ranged from 15 seconds to about 1:00 a tube.

**Results** - Curran International provided cleaned bundles to multiple NDT inspection crews ahead of schedule, there were no delays to the inspection scope. As a result of the NDT data pulled from the tube IDs, refinery inspectors identified several bundles with extreme indications of corrosion and pitting, several bundles were tagged for re-tubes during the outage. The high integrity inspection data offered the refinery base line data of the remaining exchangers, and reduced the future opportunity for unexpected outages.
